**Flood Control Project Maintenance  
Levee Inspections**

## Maintenance Issue Types Only, Levee Inspection Report By Mile - Spring 2018

### Reclamation District No. 2092 Dos Rios

Waterway	Bank	Unit Miles	Inspection Start/End	Inspector
Unit No. 01 San Joaquin River	Right	3.71	03/29/2018 03/29/2018	Richard Willoughby

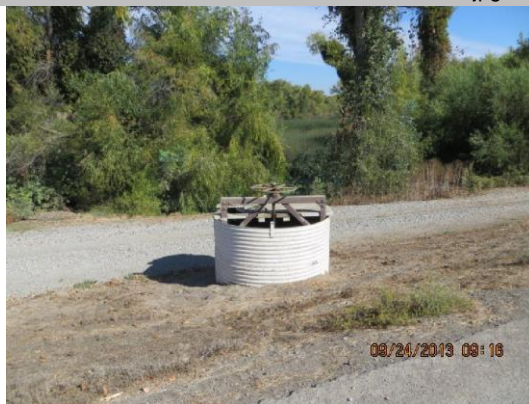
Photo 1 of 3 : UCIP\_SP\_2018\_27123\_50242.jpg

LM Start	0.18	Rating **	M	Issue No.	973
LM End	0.18	Issue Type +	Ma	Location *	
Category	Supplemental			GPS Latitude/Longitude	
				Start	End
Item	DWR UCIP LMA Responsibility			37.602031 °	37.602031 °
				-121.161249 °	-121.161249 °
DWR ID					
Comment Code					
Inspector Comment					
FS_ID:27123 DS_ID:20561 EP_NO: N/A Repair Type: Non-Urgent Crossing Status: Found UCIP Comments: Pipe rusted through at headwall on LS toe. Good candidate for video inspection. FIELD_STRUCT_DESC: 60-inch corrugated metal drainage pipe through the levee, 19 feet below the crown. Flap gate on the waterside (WS) end. Slide gate in an 80-inch corrugated metal pipe (CMP) riser on the WS slope. Concrete U-shaped headwalls on both ends. [Additional Reference(s): DWR Levee Log, 2005. USACE San Joaquin O&M Manual 5, August 1961, (HLM 0.18)]. FS Date: 1/16/2014 12:03:14 PM

Slide gate in 80-inch CMP riser on WS slope.

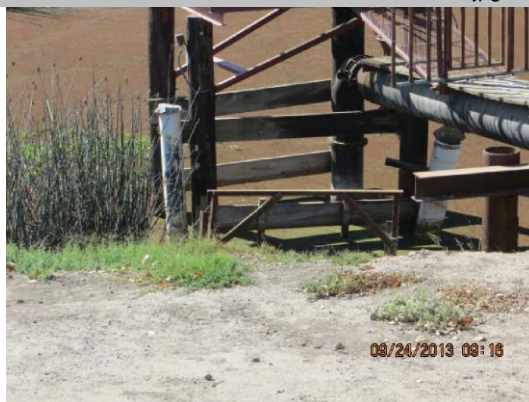
Photo 2 of 3 : UCIP\_SP\_2018\_27123\_50241.jpg

Concrete headwall on LS toe in front of pump on pier.

Comment Code					
Inspector Comment					
FS_ID:27123					
DS_ID:20561					
EP_NO: N/A					
Repair Type: Non-Urgent					
Crossing Status: Found					
UCIP Comments: Pipe rusted through at headwall on LS toe. Good candidate for video inspection.					
FIELD_STRUCT_DESC: 60-inch corrugated metal drainage pipe through the levee, 19 feet below the crown. Flap gate on the waterside (WS) end. Slide gate in an 80-inch corrugated metal pipe (CMP) riser on the WS slope. Concrete U-shaped headwalls on both ends. [Additional Reference(s): DWR Levee Log, 2005. USACE San Joaquin O&M Manual 5, August 1961, (HLM 0.18)].					
FS Date: 1/16/2014 12:03:14 PM

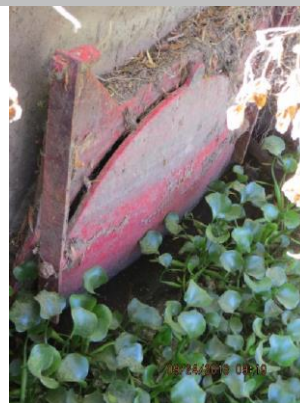
Photo 3 of 3 : UCIP\_SP\_2018\_27123\_50240.jpg

Flapgate and headwall on WS toe.

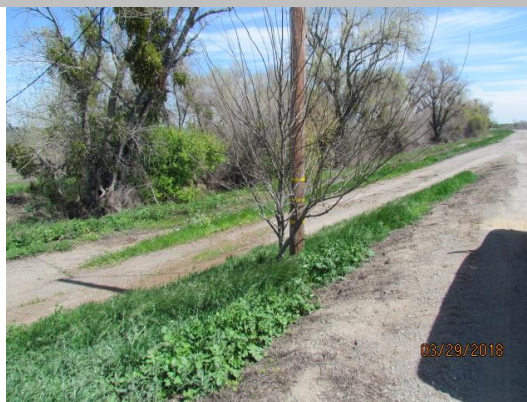
Photo 1 of 1 : SP\_2018\_RD2092\_116\_31\_20180330\_00047.jpg

LM Start	0.44	Rating **	U	Issue No.	31
LM End	0.44	Issue Type +	Ma	Location *	WS
Category	Earthen Levee			GPS Latitude/Longitude	
				Start	End
Item	Vegetation			37.601149 °	37.601149 °
				-121.165772 °	-121.165772 °
DWR ID	DWR_RD2092_01_s_2018_31				
Comment Code					
V7 : Trees / Woody Vegetation					
Inspector Comment					
Remove small tree on waterward should before tree is establish.

Looking upstream at small tree on waterward should next to pole.  
(Spring 2018)

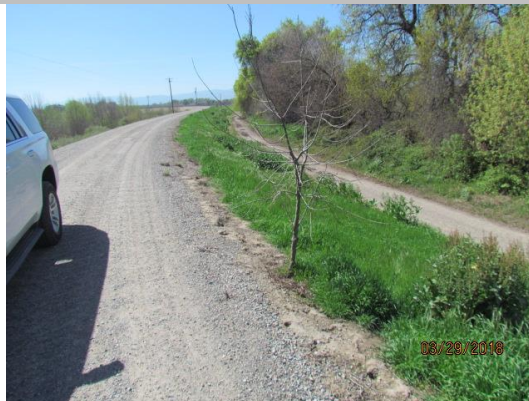
Photo 1 of 1 : SP\_2018\_RD2092\_116\_21\_20180330\_00046.jpg

LM Start	0.61	Rating **	U	Issue No.	21
LM End	0.61	Issue Type +	Ma	Location *	WS
Category	Earthen Levee			GPS Latitude/Longitude	
				Start	End
Item	Vegetation			37.599208 °	37.599208 °
				-121.167150 °	-121.167150 °
DWR ID	DWR_RD2092_01_s_2018_21				
Comment Code					
V2 : Remove the wild growth other than native grasses from the levee slopes.					
Inspector Comment					
Remove small tree on waterward shoulder before tree is establish.

Looking downstream at small tree on waterward slope. (Spring 2018)

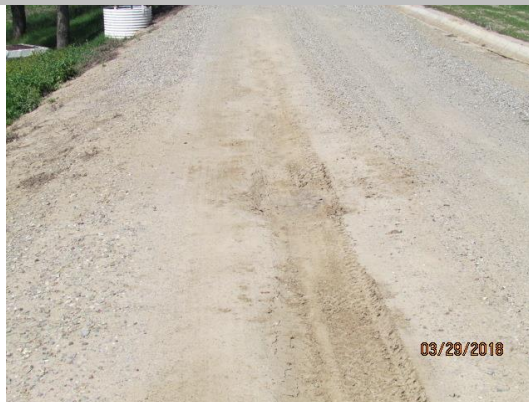
Photo 1 of 1 : SP\_2018\_RD2092\_116\_39\_20180330\_00045.jpg

LM Start	1.29	Rating **	M	Issue No.	39
LM End	1.31	Issue Type +	Ma	Location *	CR
Category	Earthen Levee			GPS Latitude/Longitude	
				Start	End
Item	Crown Surface / Depressions / Rutting			37.590701 °	37.590524 °
				-121.164339 °	-121.163947 °
DWR ID	DWR_RD2092_01_s_2017_39				
Comment Code					
C3 : Add appropriate gravel or road base. Grade and compact.					
Inspector Comment

Looking upstream at rutting and depression on levee crown. (Spring 2018)

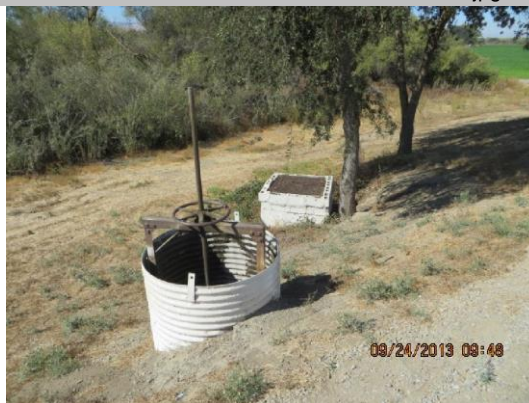
Photo 1 of 2 : UCIP\_SP\_2018\_20889\_35213.jpg

LM Start	1.30	Rating **	A/W	Issue No.	976
LM End	1.30	Issue Type +	Ma	Location *	
Category	Supplemental			GPS Latitude/Longitude	
				Start	End
Item	DWR UCIP LMA Responsibility			37.590603 °	37.590603 °
				-121.164111 °	-121.164111 °
DWR ID					
Comment Code					
Inspector Comment					
FS_ID:20889 DS_ID:20562 EP_NO: N/A Repair Type: No Action Needed Crossing Status: Found UCIP Comments: FIELD_STRUCT_DESC: 36-inch corrugated metal drainage pipe through the levee, 15 feet below the crown. Slide gate in a 48-inch corrugated metal pipe (CMP) riser on the waterside (WS) slope. 4-foot by 6-foot concrete distribution box on the landside (LS) toe. 5-foot by 5-foot concrete riser on the WS toe. [Additional Reference(s): DWR Levee Log, 2005. USACE San Joaquin O&M Manual 5, August 1961, (HLM 1.31)]. FS Date: 9/24/2013

Slide gate in 48-inch CMP riser on WS slope.

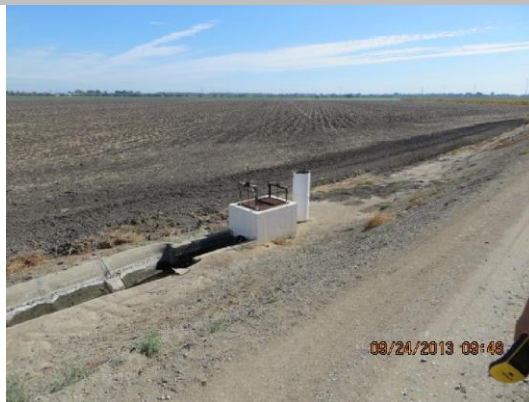
Photo 2 of 2 : UCIP\_SP\_2018\_20889\_35212.jpg

Concrete distribution box at concrete canal on LS toe.

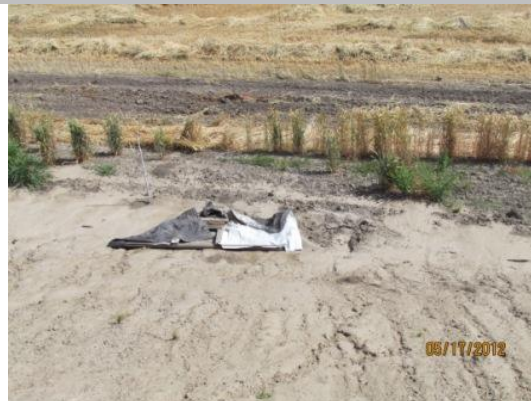
Photo 1 of 2 : SP\_2018\_RD2092\_116\_10\_20180307\_00002.jpg

LM Start	1.32	Rating **	A/W	Issue No.	10
LM End	1.32	Issue Type +	Ma	Location *	LS
Category	Earthen Levee			GPS Latitude/Longitude	
				Start	End
Item	Encroachments			37.590467 °	37.590467 °
				-121.163822 °	-121.163822 °
DWR ID	DWR_RD2092_01_s_2012_10				
Comment Code					
PI : Pipe					
Inspector Comment					
A sand boil appeared on the landside toe of the levee because of an underground pipe leakage. The pipe and boil have been repaired but should be monitored.

During spring inspection 2012, the sand boil was not active but materials were present on the landside toe of the levee. The sand boil occurred due to an underground irrigation pipe leakage. The picture was taken from the crown looking toward the toe of the levee. The area was repaired but should be monitored.

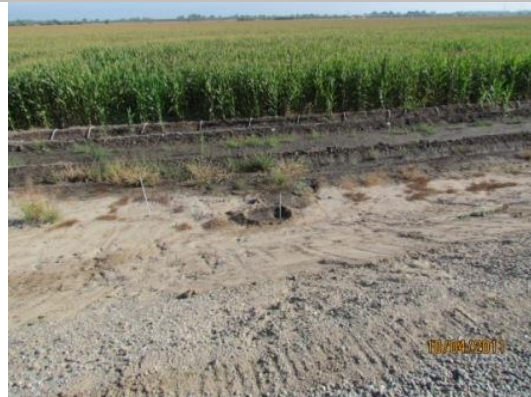
Photo 2 of 2 : SP\_2018\_RD2092\_116\_10\_20180307\_00003.jpg

A sand boil was found on the landside of the levee. It was caused by a pipe leak couple of feet below the boil location. LMA was notified to repair it as soon as possible. The picture was taken from the crown looking upstream.

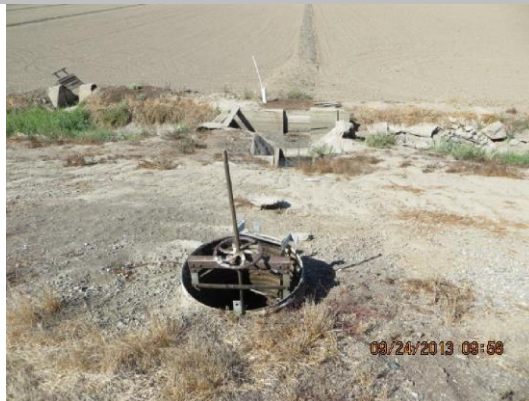
Photo 1 of 3 : UCIP\_SP\_2018\_20891\_35216.jpg

LM Start	1.69	Rating **	A/W	Issue No.	977
LM End	1.69	Issue Type +	Ma	Location *	
Category	Supplemental			GPS Latitude/Longitude	
				Start	End
Item	DWR UCIP LMA Responsibility			37.585938 °	37.585938 °
				-121.163348 °	-121.163348 °
DWR ID					
Comment Code					
Inspector Comment					
FS_ID:20891 DS_ID:20563 EP_NO: N/A Repair Type: No Action Needed Crossing Status: Found UCIP Comments: FIELD_STRUCT_DESC: 24-inch corrugated metal drainage pipe through the levee, 14 feet below the crown. Slide gate in a corrugated metal pipe (CMP) riser on the waterside (WS) slope. Concrete U-shaped headwall at the landside (LS) toe. [Additional Reference(s): DWR Levee Log, 2005. USACE San Joaquin O&M Manual 5, August 1961, (HLM 1.71)]. FS Date: 9/24/2013

Slide gate in 36-inch CMP riser on WS slope.

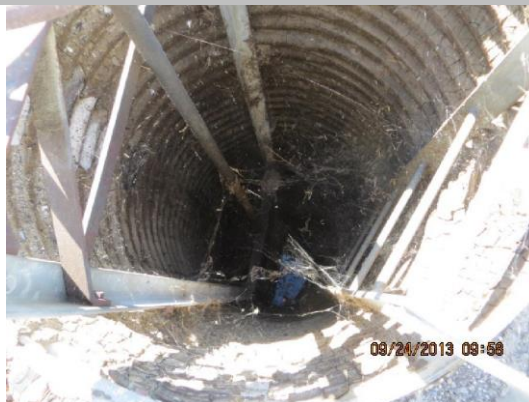
Photo 2 of 3 : UCIP\_SP\_2018\_20891\_35215.jpg

Slide gate in 36-inch CMP riser on WS slope.

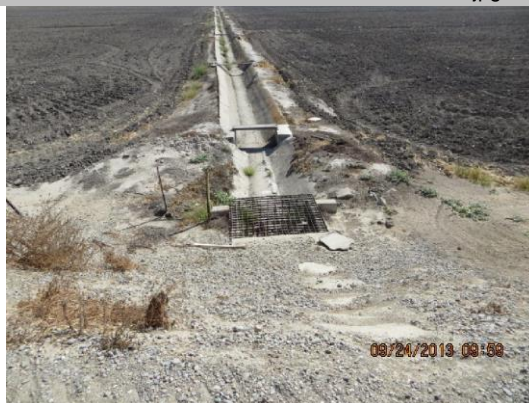
Photo 3 of 3 : UCIP\_SP\_2018\_20891\_35214.jpg

LM Start	1.69	Rating **	A/W	Issue No.	977 (cont)	
LM End	1.69	Issue Type +	Ma	Location *		
Category	Supplemental			GPS Latitude/Longitude		
				Start		End
Item	DWR UCIP LMA Responsibility			37.585938 °	37.585938 °	
				-121.163348 °	-121.163348 °	
DWR ID						
Comment Code						
Inspector Comment						
FS_ID:20891						
DS_ID:20563						
EP_NO: N/A						
Repair Type: No Action Needed						
Crossing Status: Found						
UCIP Comments:						
FIELD_STRUCT_DESC: 24-inch corrugated metal drainage pipe through the levee, 14 feet below the crown. Slide gate in a corrugated metal pipe (CMP) riser on the waterside (WS) slope. Concrete U-shaped headwall at the landside (LS) toe. [Additional Reference(s): DWR Levee Log, 2005. USACE San Joaquin O&M Manual 5, August 1961, (HLM 1.71)].						
FS Date: 9/24/2013

Concrete headwall at base of LS toe.

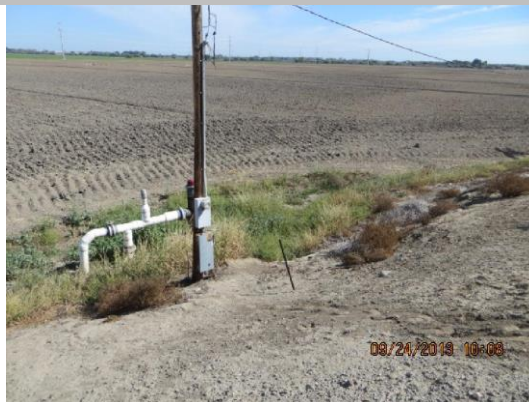
Photo 1 of 2 : UCIP\_SP\_2018\_20904\_35221.jpg

LM Start	2.07	Rating **	A/W	Issue No.	978
LM End	2.07	Issue Type +	Ma	Location *	
Category	Supplemental			GPS Latitude/Longitude	
				Start	End
Item	DWR UCIP LMA Responsibility			37.584212 °	37.584212 °
				-121.158347 °	-121.158347 °
DWR ID					
Comment Code					
Inspector Comment					
FS_ID:20904 DS_ID:20564 EP_NO: N/A Repair Type: No Action Needed Crossing Status: Found UCIP Comments: FIELD_STRUCT_DESC: *ABANDONED* 30-inch corrugated metal drainage pipe through the levee, 15 feet below the crown. Flap gate on the waterside (WS) end. Concrete U-shaped headwalls on both ends. Filled with concrete on the landside (LS) toe. [Additional Reference(s): DWR Levee Log, 2005. USACE San Joaquin O&M Manual 5, August 1961, (HLM 2.10), 36-inch pipe listed]. FS Date: 9/24/2013

Pipe and concrete headwall visible on LS toe to right of powerpole.

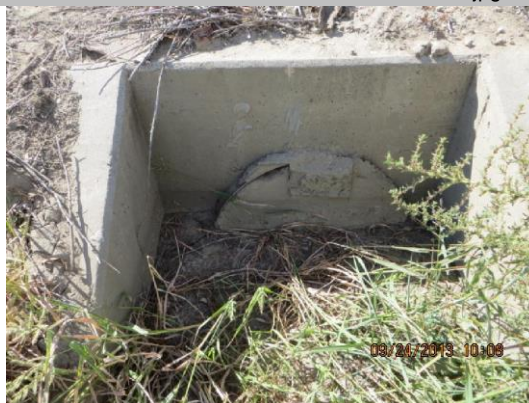
Photo 2 of 2 : UCIP\_SP\_2018\_20904\_35220.jpg

LM Start	2.07	Rating **	A/W	Issue No.	978 (cont)
LM End	2.07	Issue Type +	Ma	Location *	
Category	Supplemental			GPS Latitude/Longitude	
				Start	End
Item	DWR UCIP LMA Responsibility			37.584212 °	37.584212 °
				-121.158347 °	-121.158347 °
DWR ID					
Comment Code					
Inspector Comment					
FS_ID:20904 DS_ID:20564 EP_NO: N/A Repair Type: No Action Needed Crossing Status: Found UCIP Comments: FIELD_STRUCT_DESC: *ABANDONED* 30-inch corrugated metal drainage pipe through the levee, 15 feet below the crown. Flap gate on the waterside (WS) end. Concrete U-shaped headwalls on both ends. Filled with concrete on the landside (LS) toe. [Additional Reference(s): DWR Levee Log, 2005. USACE San Joaquin O&M Manual 5, August 1961, (HLM 2.10), 36-inch pipe listed]. FS Date: 9/24/2013

Pipe and concrete headwall visible on LS toe.

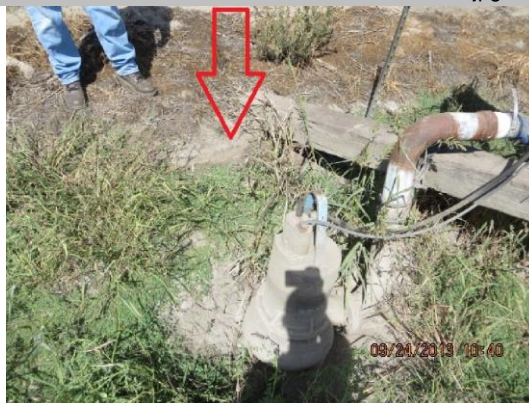
Photo 3 of 3 : UCIP\_SP\_2018\_20943\_35252.jpg

LM Start	2.40	Rating **	M	Issue No.	981 (cont)
LM End	2.40	Issue Type +	Ma	Location *	
Category	Supplemental			GPS Latitude/Longitude	
				Start	End
Item	DWR UCIP LMA Responsibility			37.580426 °	37.580426 °
				-121.156798 °	-121.156798 °
DWR ID					
Comment Code					
Inspector Comment					
FS_ID:20943 DS_ID:20567 EP_NO: N/A Repair Type: Non-Urgent Crossing Status: Found UCIP Comments: Appears abandoned and if so should be done so properly. FIELD_STRUCT_DESC: *ABANDONED* 24-inch corrugated metal drainage pipe through the levee, 15 feet below the crown. Flap gate on the waterside (WS) end. Concrete U-shaped headwall on the WS end. Concrete headwall on the landside (LS) toe next to pump. [Additional Reference(s): DWR Levee Log, 2005. USACE San Joaquin O&M Manual 5, August 1961, (HLM 2.44)]. FS Date: 9/24/2013

Concrete headwall next to pump on WS toe.

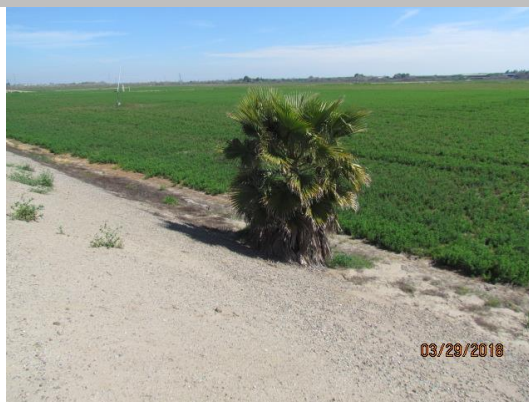
Photo 1 of 1 : SP\_2018\_RD2092\_116\_19\_20180330\_00044.jpg

LM Start	2.55	Rating **	U	Issue No.	19
LM End	2.55	Issue Type +	Ma	Location *	LS
Category	Earthen Levee			GPS Latitude/Longitude	
				Start	End
Item	Vegetation			37.578333 °	37.578333 °
				-121.157011 °	-121.157011 °
DWR ID	DWR_RD2092_01_s_2018_19				
Comment Code					
V7 : Trees / Woody Vegetation					
Inspector Comment					
Palm tree at landward toe should be removed.

Looking at Palm tree at landward toe. (Spring 2018)

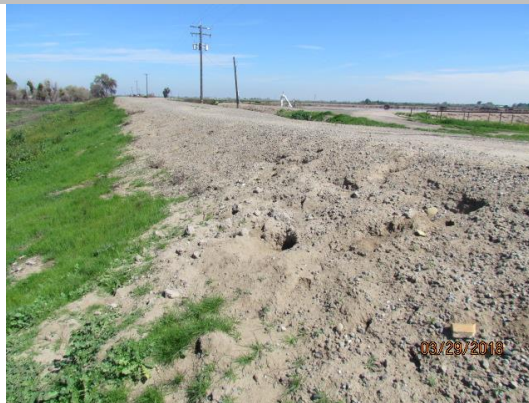
Photo 1 of 4 : SP\_2018\_RD2092\_116\_17\_20180330\_00041.jpg

LM Start	2.63	Rating **	U	Issue No.	17
LM End	2.72	Issue Type +	Ma	Location *	WS
Category	Earthen Levee			GPS Latitude/Longitude	
				Start	End
Item	Animal Control			37.577186°	37.575843°
				-121.157159°	-121.157228°
DWR ID	DWR_RD2092_01_s_2018_17				
Comment Code					
A1 : Exterminate rodents and backfill and compact or grout burrows.					
Inspector Comment					
Several large rodent holes within this reach.

Looking upstream on waterward slope at several large rodent holes.  
(Spring 2018)

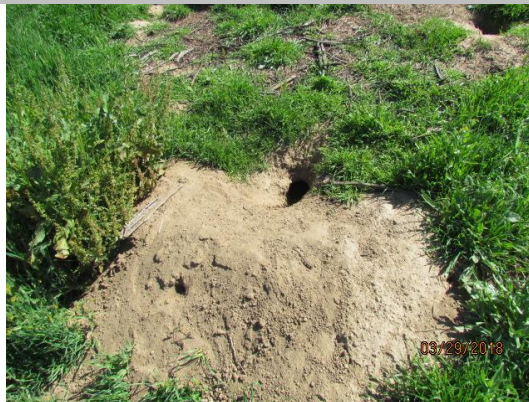
Photo 2 of 4 : SP\_2018\_RD2092\_116\_17\_20180330\_00042.jpg

Looking at typical large rodent holes on waterward slope. (Spring 2018)

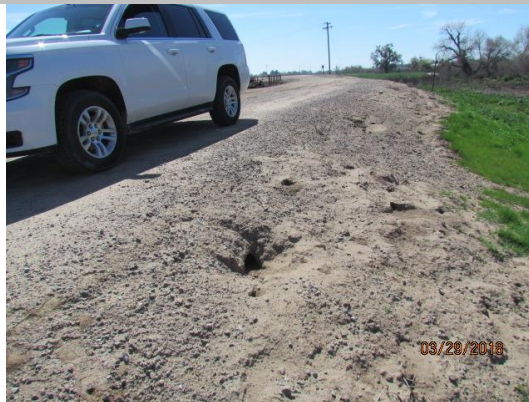
Photo 3 of 4 : SP\_2018\_RD2092\_116\_17\_20180330\_00040.jpg

Looking downstream at several rodent holes on waterward slope.  
(Spring 2018)

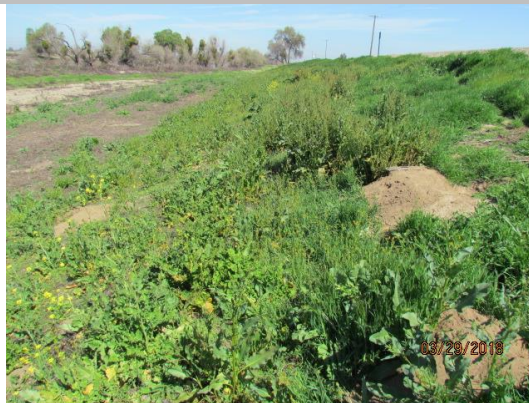
Photo 4 of 4 : SP\_2018\_RD2092\_116\_17\_20180330\_00043.jpg

LM Start	2.63	Rating **	U	Issue No.	17 (cont)	
LM End	2.72	Issue Type +	Ma	Location *	WS	
Category	Earthen Levee			GPS Latitude/Longitude		
				Start		End
Item	Animal Control			37.577186 °		37.575843 °
				-121.157159 °		-121.157228 °
DWR ID	DWR_RD2092_01_s_2018_17					
Comment Code						
A1 : Exterminate rodents and backfill and compact or grout burrows.						
Inspector Comment						
Several large rodent holes within this reach.

Looking upstream at large rodent holes on waterward slope. (Spring 2018)

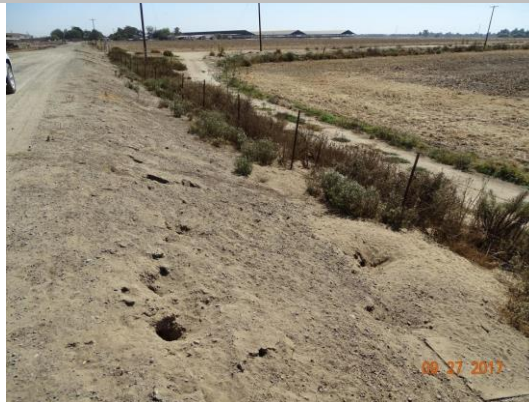
Photo 1 of 4 : SP\_2018\_RD2092\_116\_35\_20180307\_00006.jpg

LM Start	2.82	Rating **	U	Issue No.	35
LM End	3.01	Issue Type +	Ma	Location *	WS
Category	Earthen Levee			GPS Latitude/Longitude	
				Start	End
Item	Animal Control			37.574869 °	37.574141 °
				-121.156247 °	-121.152762 °
DWR ID	DWR_RD2092_01_s_2017_35				
Comment Code					
A3 : No rodents visible, but rodent burrows visible; need to backfill and compact or grout burrows.					
Inspector Comment

Updated picture of the rodent holes on the waterside of the levee looking upstream. Fall 2017

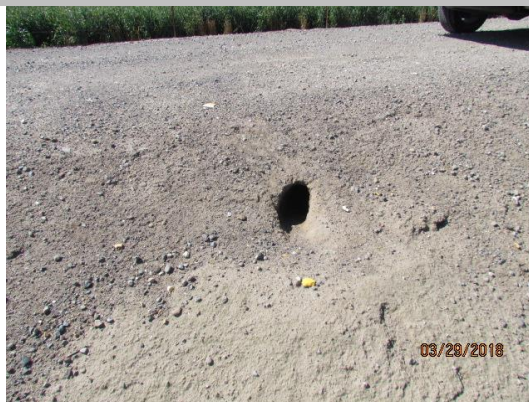
Photo 3 of 4 : SP\_2018\_RD2092\_116\_35\_20180330\_00038.jpg

Looking at Typical view of rodent holes on landward slope within this reach. (Spring 2018)

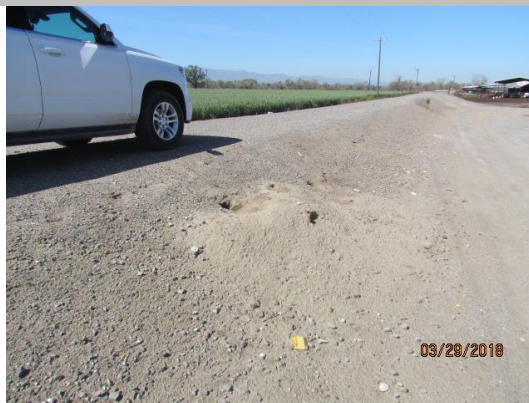
Photo 4 of 4 : SP\_2018\_RD2092\_116\_35\_20180330\_00039.jpg

LM Start	2.82	Rating **	U	Issue No.	35 (cont)	
LM End	3.01	Issue Type +	Ma	Location *	WS	
Category	Earthen Levee			GPS Latitude/Longitude		
				Start		End
Item	Animal Control			37.574869 °		37.574141 °
				-121.156247 °		-121.152762 °
DWR ID	DWR_RD2092_01_s_2017_35					
Comment Code						
A3 : No rodents visible, but rodent burrows visible; need to backfill and compact or grout burrows.						
Inspector Comment

Looking upstream at several rodent holes on landward slope. (Spring 2018)

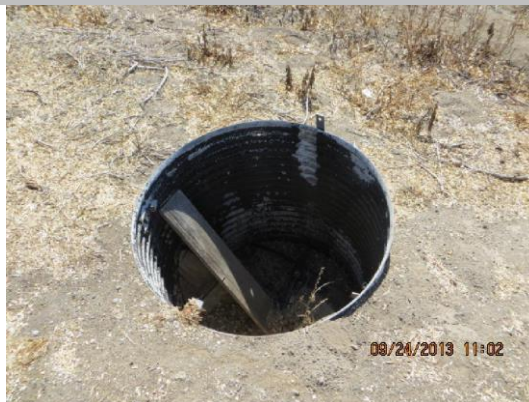
Photo 1 of 3 : UCIP\_SP\_2018\_20945\_35261.jpg

LM Start	3.47	Rating **	M	Issue No.	984
LM End	3.47	Issue Type +	Ma	Location *	
Category	Supplemental			GPS Latitude/Longitude	
				Start	End
Item	DWR UCIP LMA Responsibility			37.573304 °	37.573304 °
				-121.144747 °	-121.144747 °
DWR ID					
Comment Code					
Inspector Comment					
FS_ID:20945 DS_ID:20572 EP_NO: N/A Repair Type: Non-Urgent Crossing Status: Found UCIP Comments: This pipe appears abandoned and if so, should be done so properly. FIELD_STRUCT_DESC: *ABANDONED* 36-inch corrugated metal drainage pipe through the levee, 11 feet below the crown. Slide gate in a corrugated metal pipe (CMP) riser on the waterside (WS) slope. Concrete headwalls on both ends. [Additional Reference(s): DWR Levee Log, 2005. USACE San Joaquin O&M Manual 5, August 1961, (HLM 3.52)]. FS Date: 9/24/2013

48-inch CMP riser on WS slope.

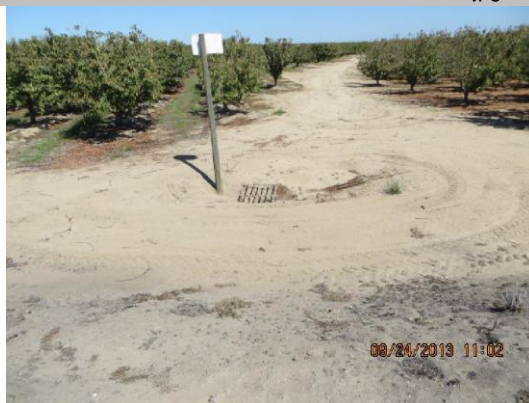
Photo 2 of 3 : UCIP\_SP\_2018\_20945\_35260.jpg

LM Start	3.47	Rating **	M	Issue No.	984 (cont)	
LM End	3.47	Issue Type +	Ma	Location *		
Category	Supplemental			GPS Latitude/Longitude		
				Start		End
Item	DWR UCIP LMA Responsibility			37.573304 °	37.573304 °	
				-121.144747 °	-121.144747 °	
DWR ID						
Comment Code						
Inspector Comment						
FS_ID:20945 DS_ID:20572 EP_NO: N/A Repair Type: Non-Urgent Crossing Status: Found UCIP Comments: This pipe appears abandoned and if so, should be done so properly. FIELD_STRUCT_DESC: *ABANDONED* 36-inch corrugated metal drainage pipe through the levee, 11 feet below the crown. Slide gate in a corrugated metal pipe (CMP) riser on the waterside (WS) slope. Concrete headwalls on both ends. [Additional Reference(s): DWR Levee Log, 2005. USACE San Joaquin O&M Manual 5, August 1961, (HLM 3.52)]. FS Date: 9/24/2013

Grate over sump on LS toe.

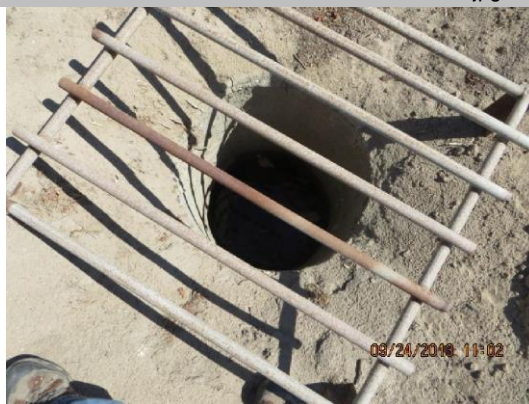
Photo 3 of 3 : UCIP\_SP\_2018\_20945\_35262.jpg

Grate over sump on LS toe.
